# **INDOOR AIR QUALITY ASSESSMENT**

**Leicester Memorial Elementary School  
11 Memorial School Drive  
Leicester, MA 01524**

Prepared by:  
Massachusetts Department of Public Health  
Center for Environmental Health  
Emergency Response/Indoor Air Quality Program  
May, 2005

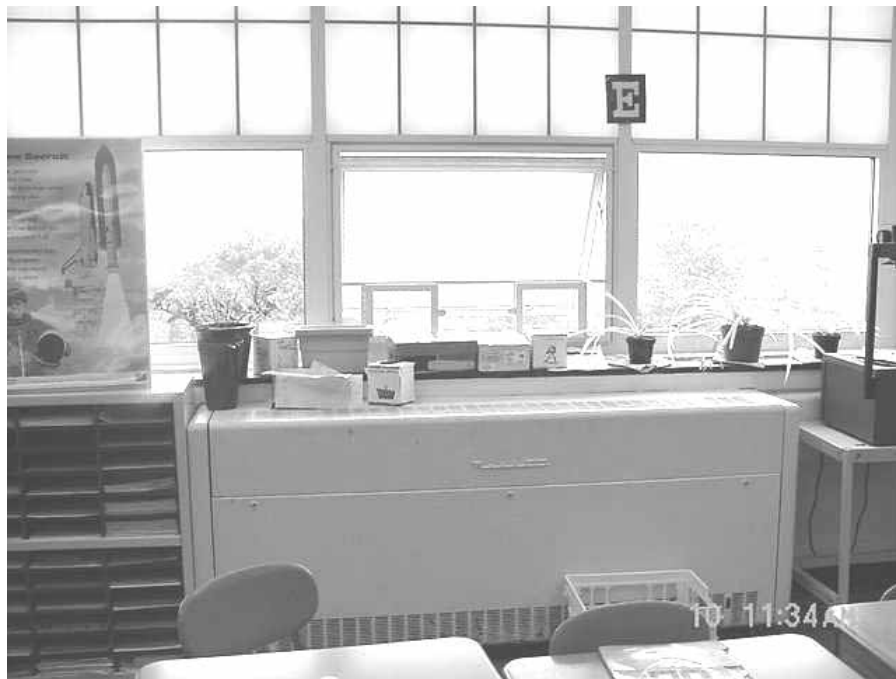
Picture 1

Fresh air in classrooms is supplied by unit ventilator (univent) systems (Picture 1). A univent draws air from outdoors through a fresh air intake located on the exterior wall of the building (Picture 2) and returns air through an air intake located at the base of the unit ([Figure 1](#)). Fresh and return air are mixed, filtered, heated and provided to classrooms through an air diffuser located in the top of the unit. Some univents were not operating or were operating weakly at the time of the assessment. Obstructions to airflow, such as desks and other items located on or in front of univents, were also observed (Picture 1). To function as designed, univents must be allowed to operate and remain free of obstructions.

Classroom univent

1. Operate mechanical supply and exhaust ventilation during occupancy. Inspect exhaust motors and belts periodically for proper function, repair and replace as necessary.

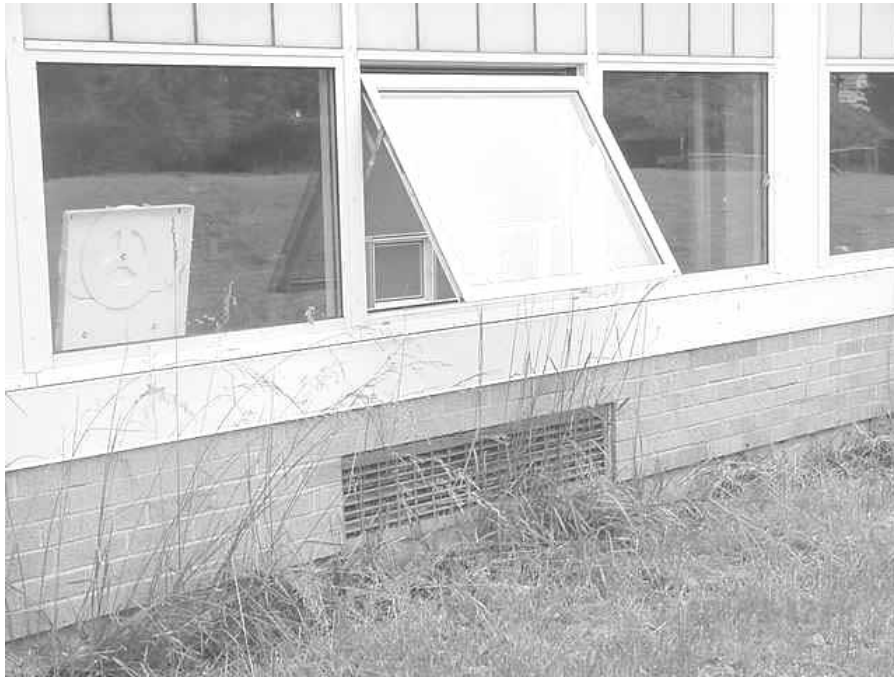
Picture 2

Exterior univent fresh air intake

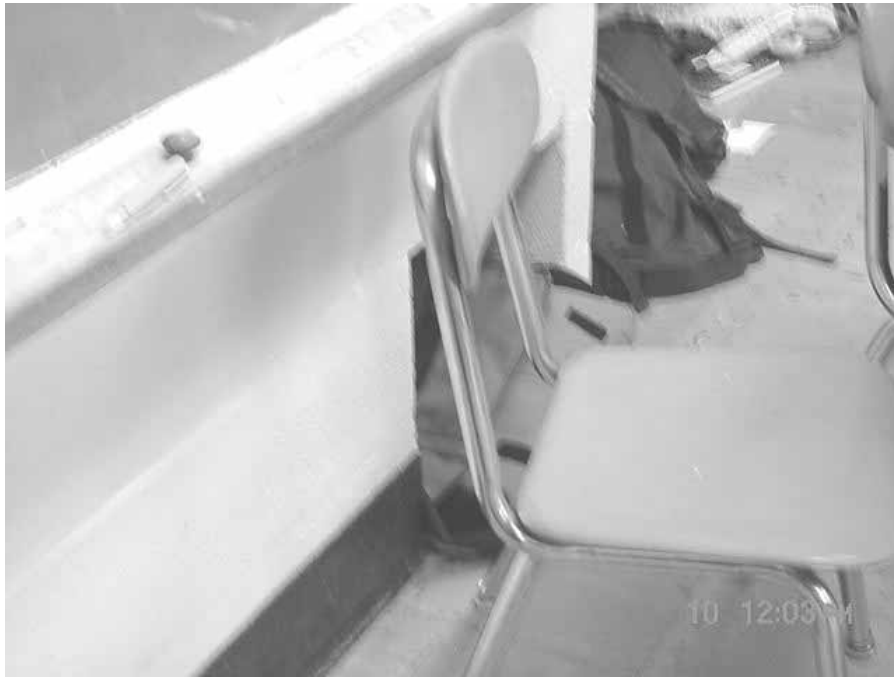
Picture 3

Exhaust ventilation is provided by a mechanical system that draws air into ungrated floor level holes in classrooms. Airflow is controlled by a flue located inside the duct. This system appeared to be operating in all classrooms. Some exhaust holes were blocked by items (Picture 3). As with univents, exhaust ventilation must remain free of obstructions to function as designed.

Blockage to exhaust cubbyhole

2. Keep univents and exhaust ventilation free and clear of obstructions. Examine flue systems periodically for proper function, repair if necessary.
3. Once both the fresh air supply and the exhaust ventilation are functioning, the ventilation system should be balanced.

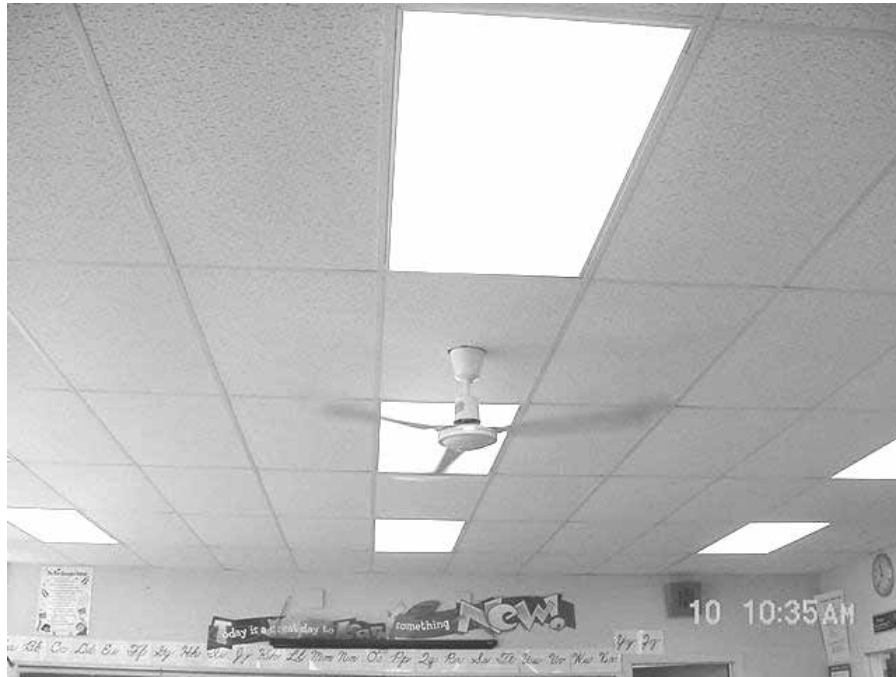
Picture 4

In addition to mechanical ventilation, most rooms at the MS also have ceiling fans (Picture 4). These ceiling fans help to circulate air within the room, especially during warmer months when windows are open. At the time of the assessment, many classroom ceiling fans were operating, especially in rooms where univents were off/operating weakly and windows were open.

Classroom ceiling fan

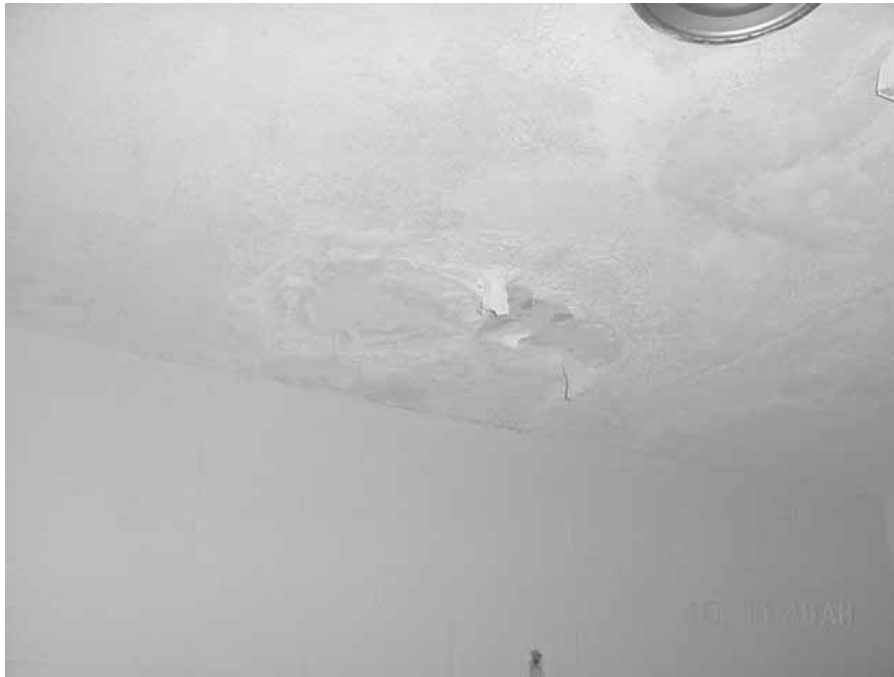
Picture 5

Water-damaged ceiling plaster and efflorescence was noted in some areas, especially in the gym area (Picture 5). Efflorescence appears as a white, chalky residue and is a characteristic sign of water damage, but it is not mold growth. As moisture penetrates and works its way through plaster, water-soluble compounds dissolve, creating

Water-damaged ceiling plaster

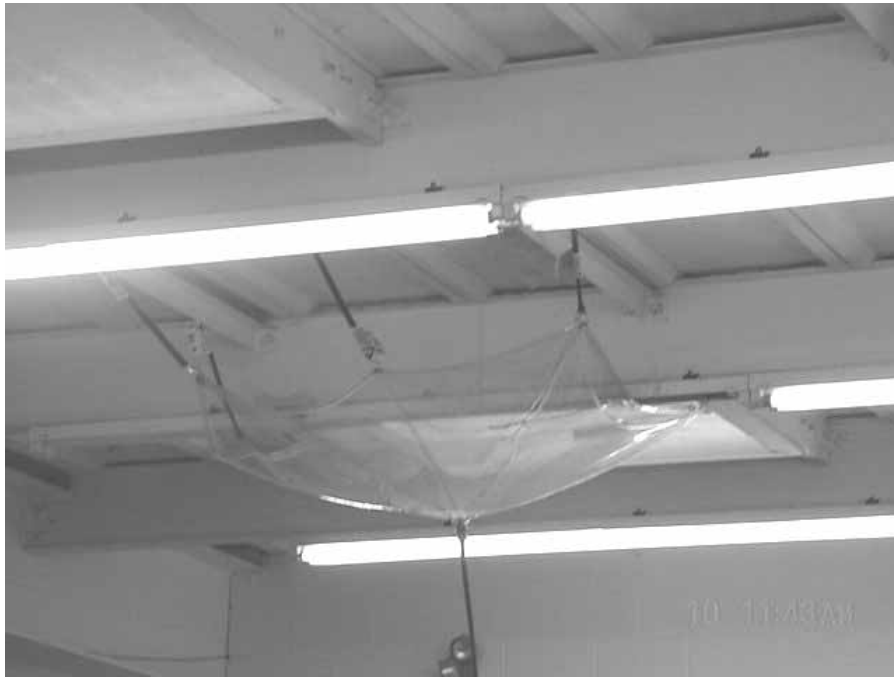
Picture 6

a solution. As the solution moves to the surface, the water evaporates, leaving behind white, powdery mineral deposits. A coat of paint can serve as a water impermeable barrier, which can trap moisture. While plaster is not a viable source for mold growth, water trapped in spaces between the paint and plaster can become mold growth media. It appears that a plastic water catching apparatus was also assembled in the gym (Picture 6).

Plastic water catching apparatus

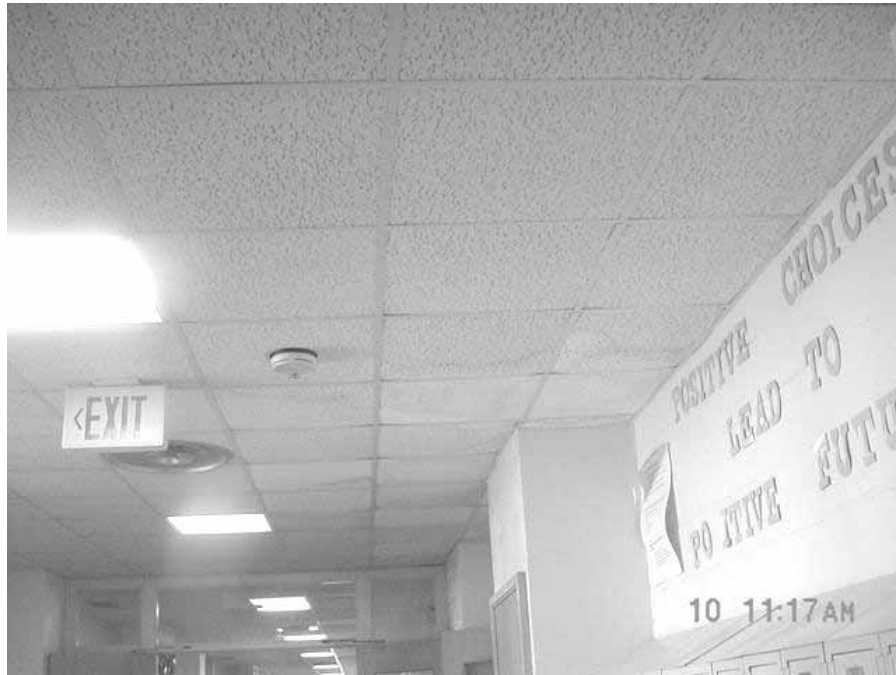
Picture 7

Water-damaged ceiling tiles were noted in the library and other areas of the school. Such damage was noted in both the drop ceiling tile systems (Picture 7) and the older ceiling tiles, which are glued directly to the ceiling throughout the building (Picture 8). Water-damaged ceiling tiles are evidence of historic roof or plumbing leaks. These ceiling tiles can provide a source of mold and should be replaced after a water leak is discovered and repaired.

Water damage to ceiling tiles in the drop ceiling tile system

4. Continue to replace water-stained ceiling tiles. Examine the area above these tiles for mold growth. Disinfect areas of water leaks with an appropriate antimicrobial.

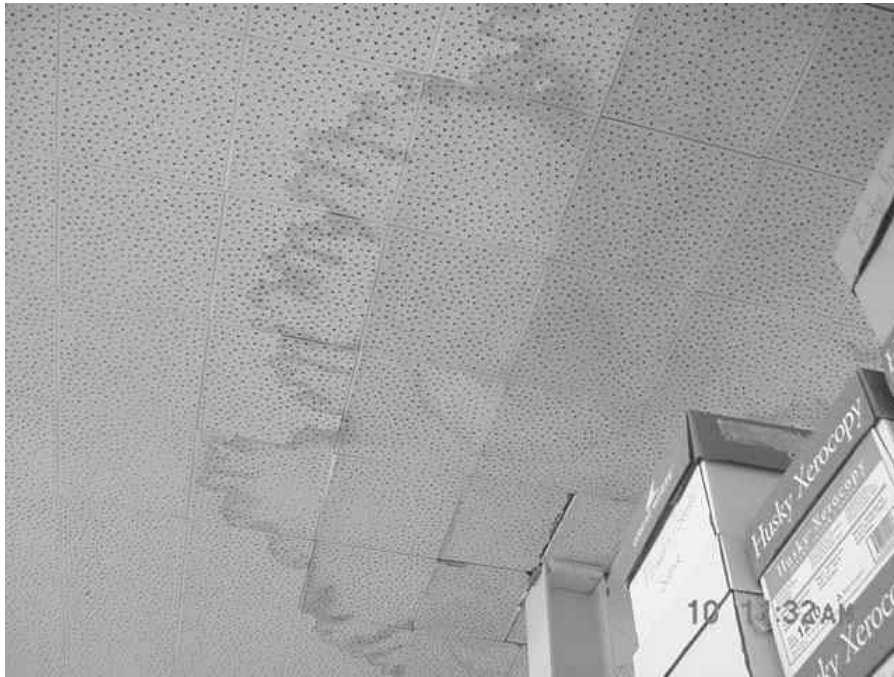
Picture 8

Water damage to ceiling tiles in the glued ceiling tile system

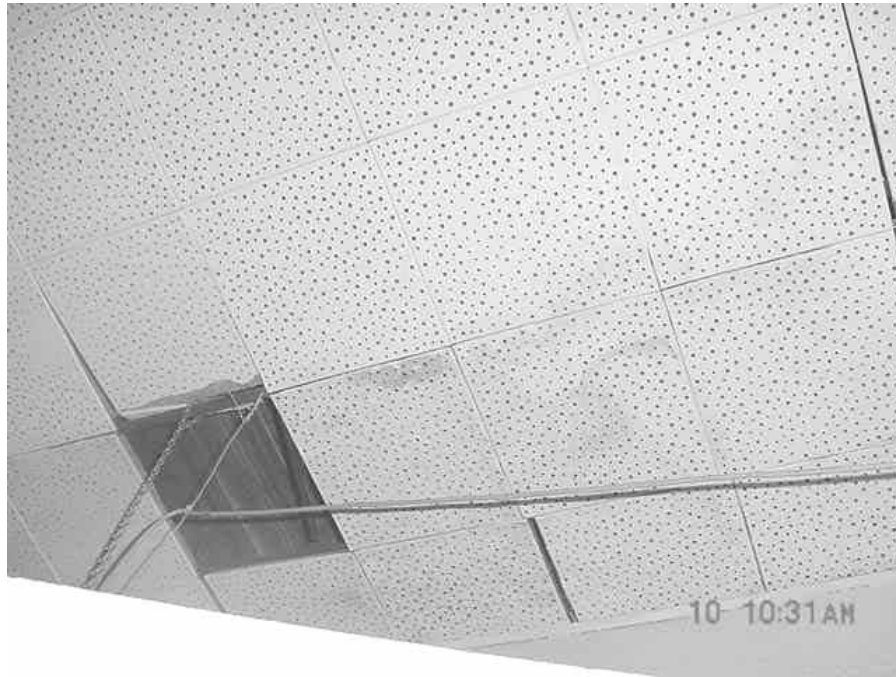
Picture 9

In some areas of the library, ceiling tiles from the drop system were missing. MDPH staff observed that the original glued ceiling tiles were still intact above the drop ceiling tile system (Picture 9). Missing ceiling tiles can serve as pathways for dust, dirt, odors and other pollutants to move into occupied areas. As previously discussed, water-damaged ceiling tiles can serve as a source for mold growth. Consideration should be given to removing all water-damaged glued ceiling tiles from the library.

Water-damaged glued ceiling tiles above drop ceiling system in library

5. Consider removing all water-damaged glued ceiling tiles that are intact above the current drop ceiling system in the library.
6. Keep plants away from univents in classrooms. Examine drip pans periodically for mold growth and disinfect areas of water leaks with an appropriate antimicrobial where necessary.

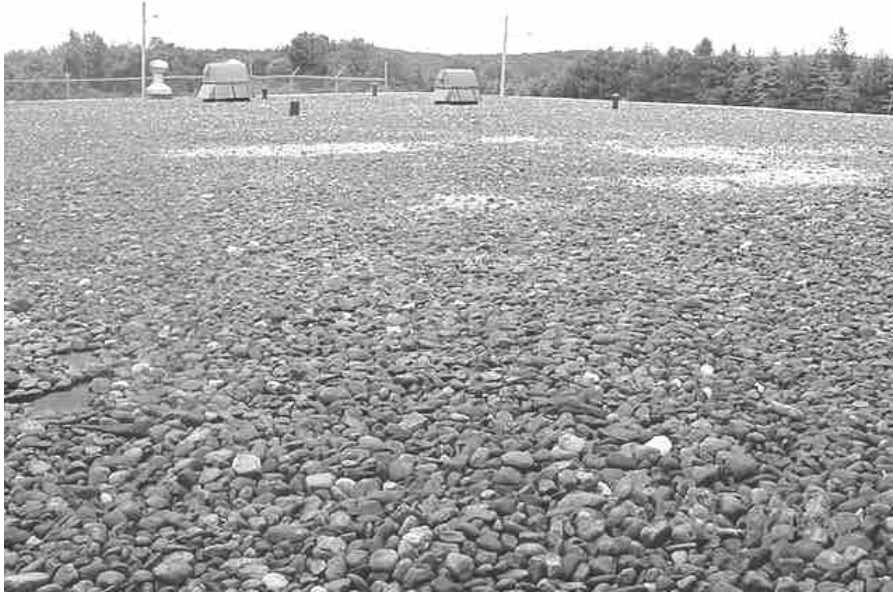
Picture 10

As discussed, the purpose of this reassessment was to assess water damage to ceiling materials in the library. According to school personnel, there are active roof leaks causing water damage to materials in this area. MDPH staff observed the roof and noted areas with pooling water (Picture 10). The rubber membrane also appeared degraded and cracked in some areas (Picture 11). Repairing/replacing the roof is necessary to prevent further water penetration.

Pooling water on roof

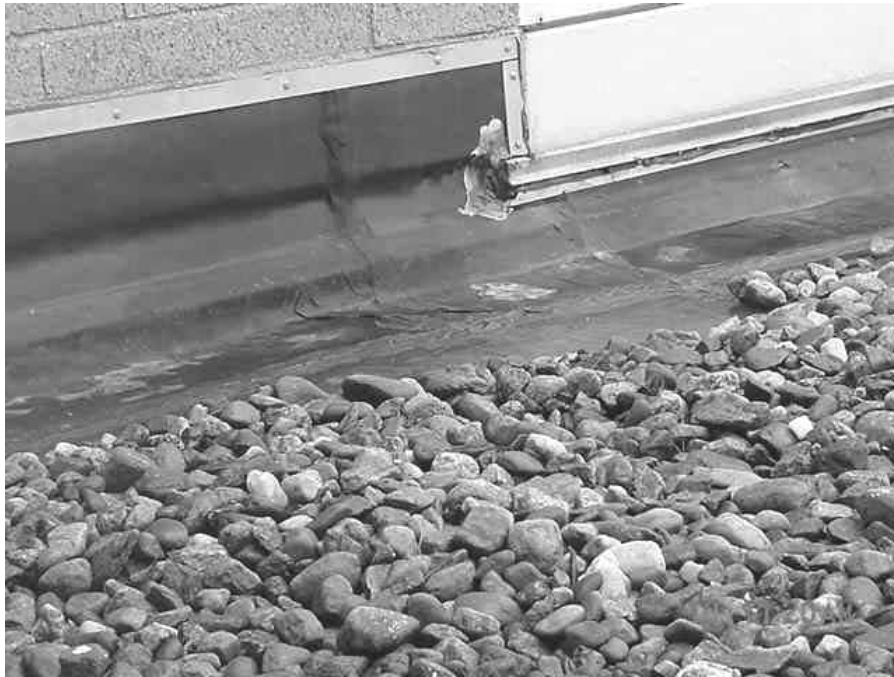
Picture 11

Damage to roof membrane, note cracks rubber and efflorescence from building

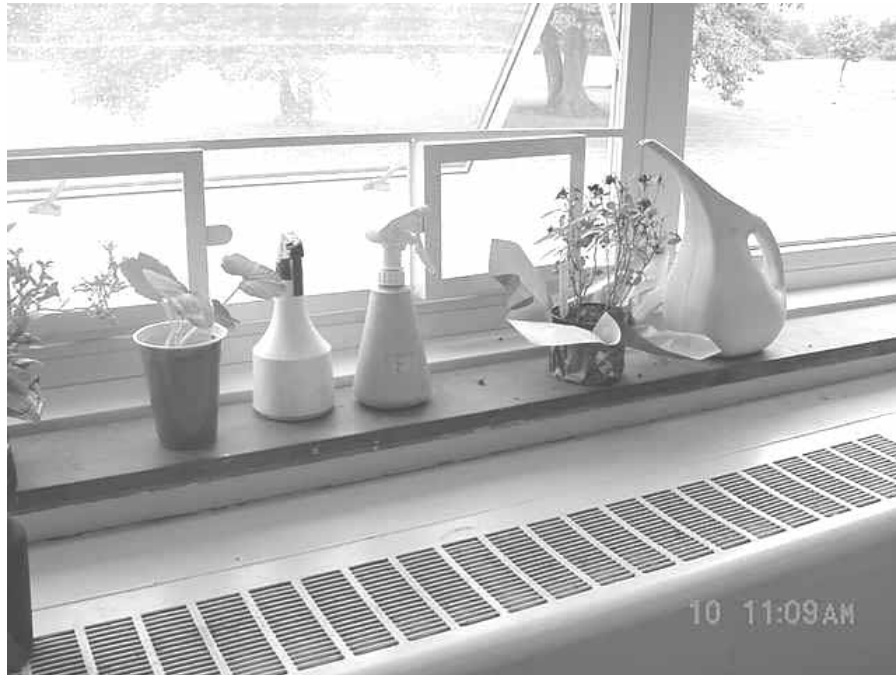
Picture 13

Several rooms contained a number of plants (Picture 13). Plant soil and drip pans can provide a source of mold growth. Over-watering of plants should be avoided and drip pans should be inspected periodically for mold growth. Plants should have drip pans to prevent wetting and subsequent mold colonization of window frames. Plants should also be located away from ventilation sources to prevent the aerosolization of mold, dirt and pollen.

Plants, note proximity to univent

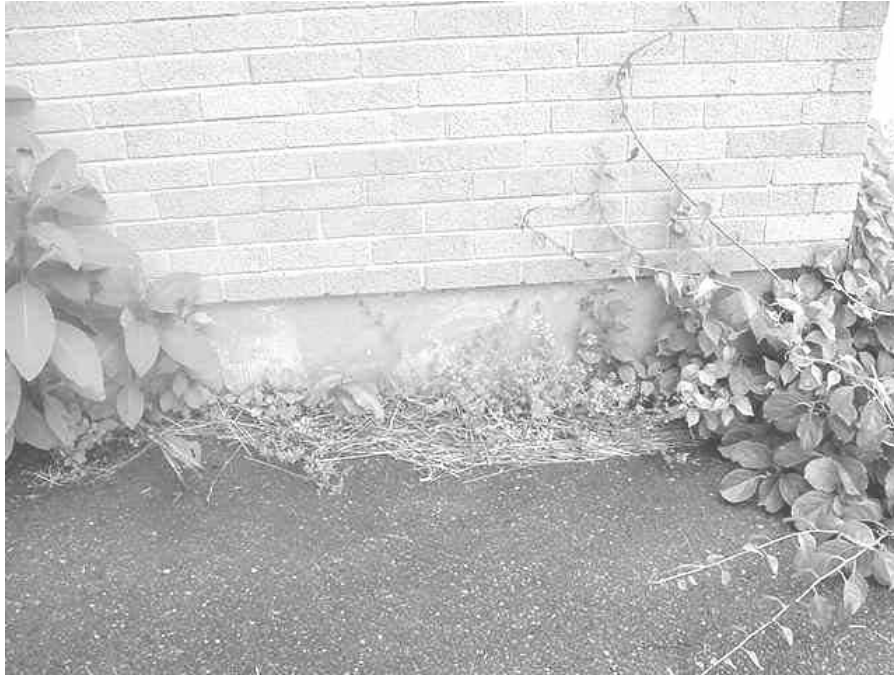
Picture 14

Shrubby and other plants were growing in close proximity to foundation walls (Picture 14). The growth of roots against the exterior walls can bring moisture in contact

with wall brick. Plant roots can eventually penetrate the brick, leading to cracks and/or fissures in the below ground level foundation. Over time, this process can undermine the integrity of the building envelope, providing a means of water entry into the building through foundation concrete and masonry by capillary action (Lstiburek & Brennan, 2001).

Plant growth in close proximity to foundation wall

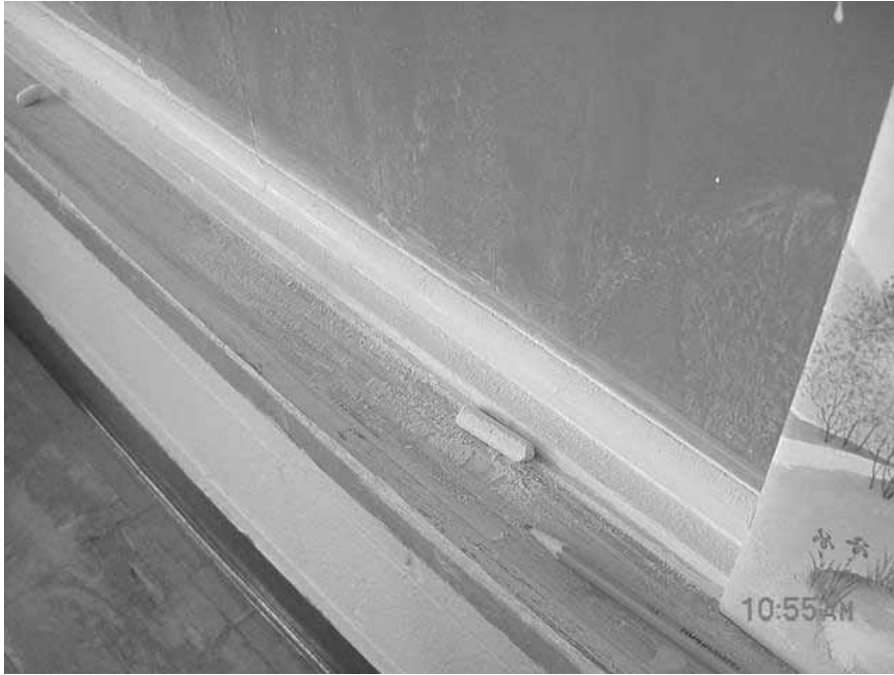
Picture 15

Other conditions that can contribute to the indoor air environment includes excessive chalk dust, which was noted in chalk trays of several classrooms (Picture 15).

Chalk can become easily aerosolized and serve as an eye and respiratory irritant. To prevent dust aerosolization, a wet cloth should be used to clean the chalk trays regular.

Accumulated chalk dust in tray

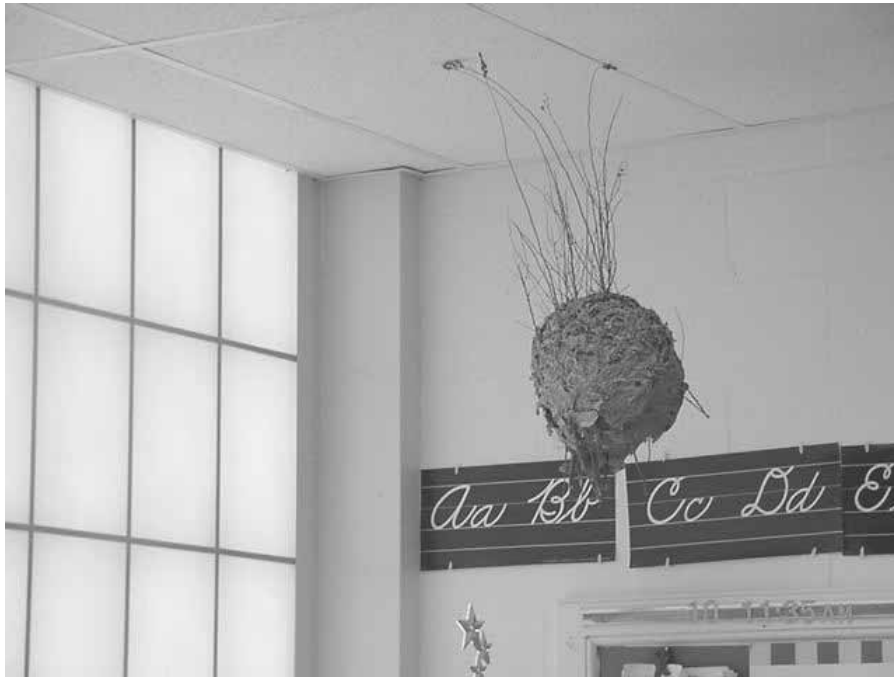
Picture 16

An inactive insect nest was noted suspended from the ceiling system in one classroom (Picture 16). Nests can contain bacteria and may also be a source of allergenic material. Nests should be placed in resealable bags to prevent aerosolization of allergenic material. These items should also be located away from univents fresh air diffusers. In addition, items should not be suspended from ceiling tile systems. Movement of ceiling tiles may aerosolize dust above ceiling tiles. Moreover, heavy items may damage the ceiling tile frames.

Insect nest suspended from ceiling tile system

9. Consider removing or placing the insect nest into a resealable plastic bag to prevent aerosolization of irritants.
10. Clean and maintain animal cages to prevent bacterial/mold growth and/or odors.
11. Clean chalk boards and chalk trays regularly to avoid the excessive build-up of chalk dust.
12. Consider adopting the US EPA (2000b) document, *Tools for Schools*, in order to provide self assessment and maintain a good indoor air quality environment. The document can be downloaded from the Internet at <http://www.epa.gov/iaq/schools/index.html>.
13. Refer to resource manuals and other related indoor air quality documents for further building-wide evaluations and advice on maintaining public buildings. Copies of these materials are located on the MDPH's website: <http://www.state.ma.us/dph/beha/iaq/iaqhoFtme.htm>.

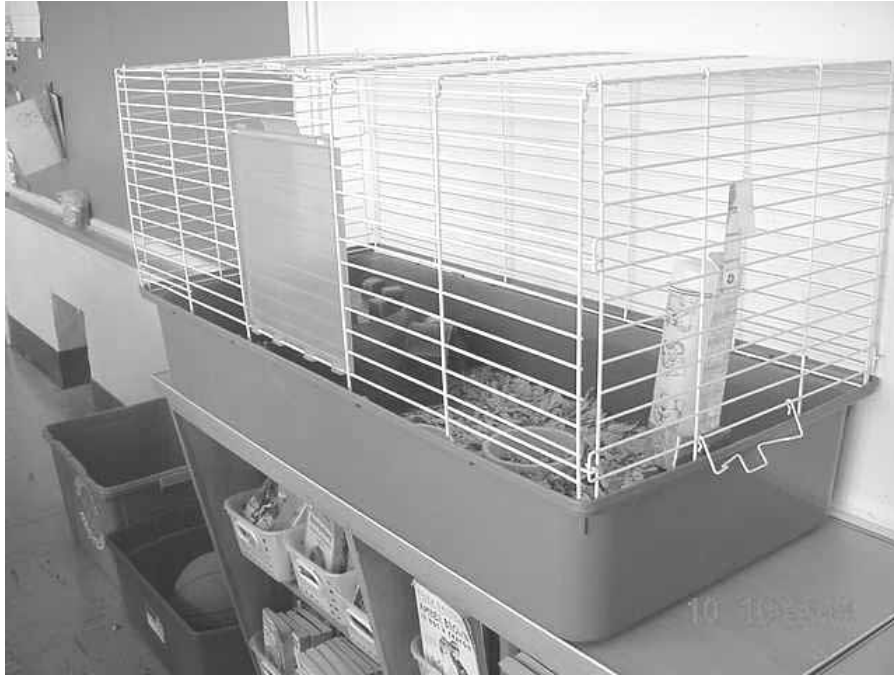
Picture 17

A pet guinea pig was found in one classroom (Picture 17). The cage was lined with wood shavings and had accumulated wastes. Porous materials (i.e., wood shavings) can absorb animal wastes and can be a reservoir for mold and bacterial growth. Animal dander, fur and wastes can all be sources of respiratory irritants. Animal cages should be cleaned regularly to avoid the aerosolization of allergenic materials and/or odors.

Guinea pig cage
